HIGH QUALITY BASEMENT ACCOMMODATION IN OLDER HOUSES

THE PROJECT IMPLEMENTATION DIVISION
POLICY DEVELOPMENT AND RESEARCH SECTOR
CANADA MORTGAGE AND HOUSING CORPORATION

THORCOR HOLDINGS LTD.
PROPERTY INVESTMENT AND DEVELOPMENT
OTTAWA, ONTARIO

1.1 Retrofit of 177 Frank Street

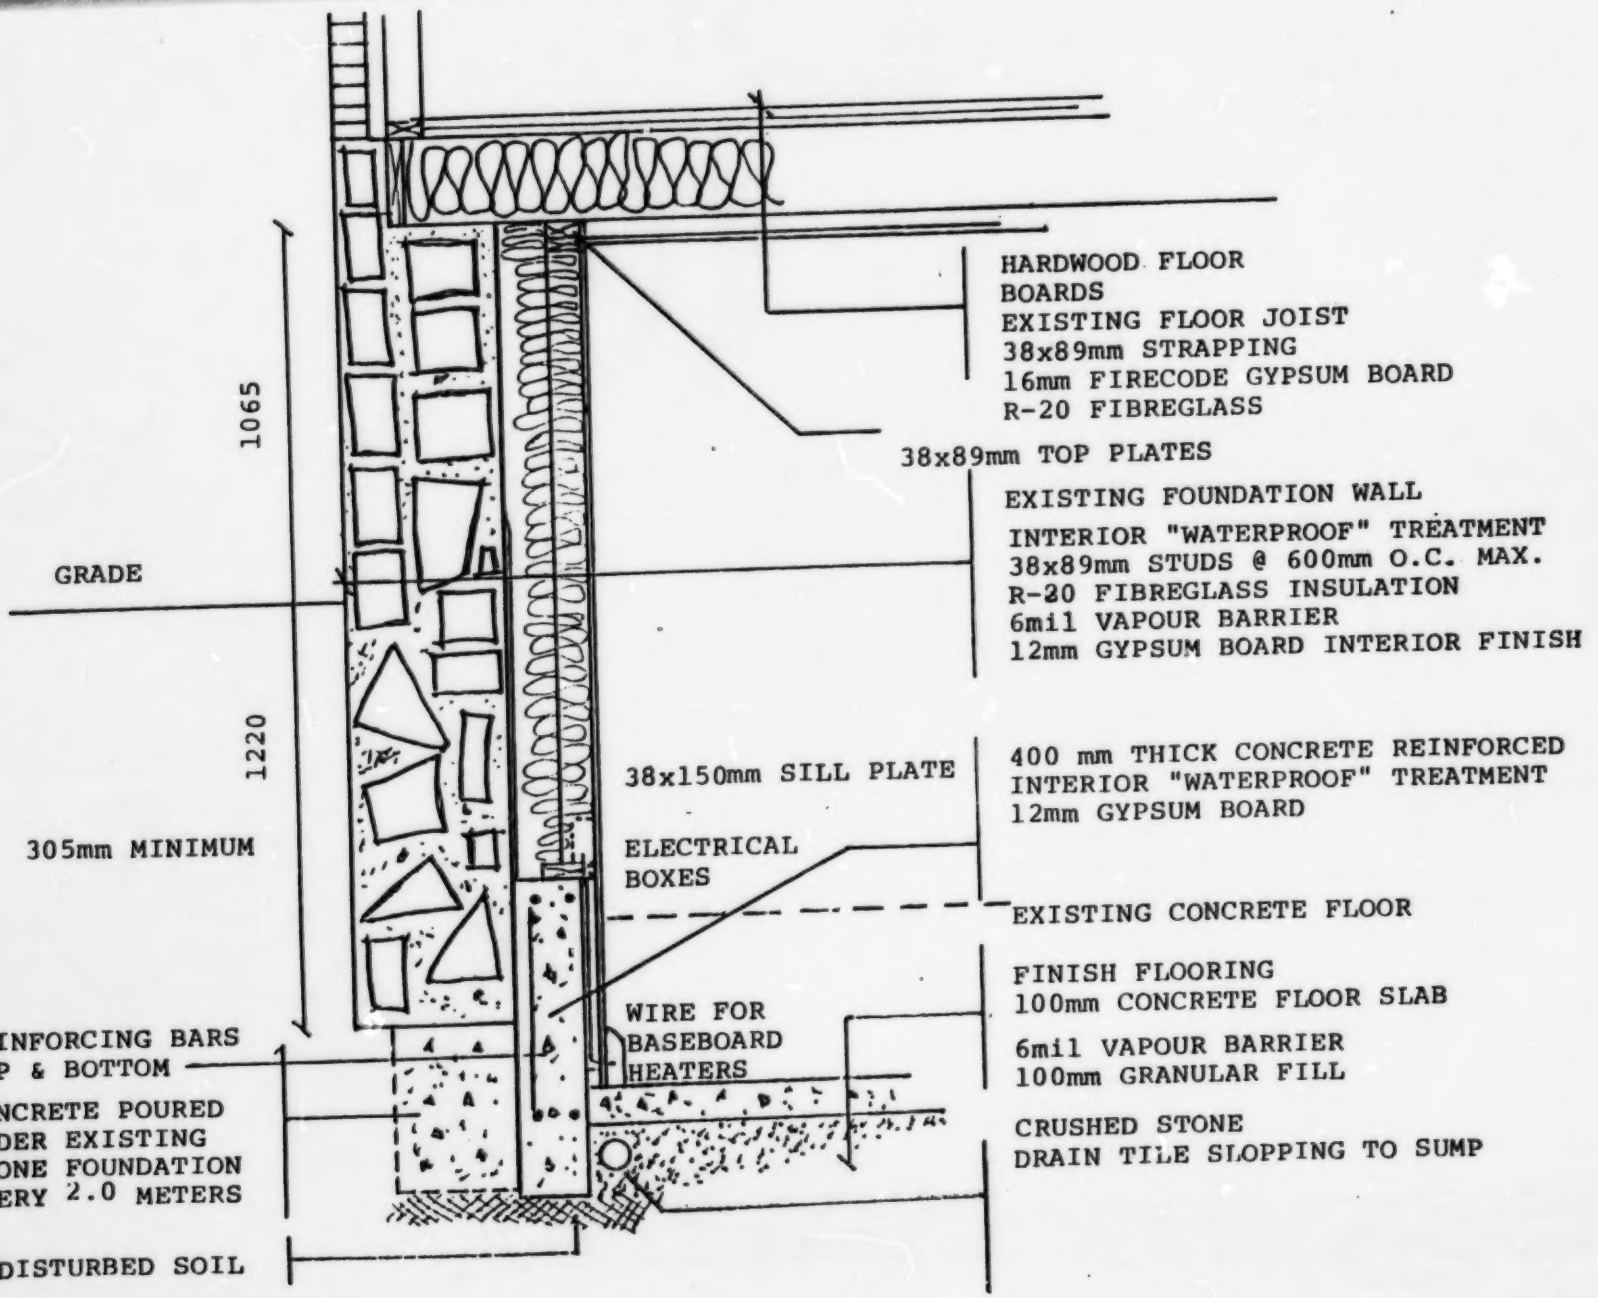
FIGURE 1

Exterior walls were framed with 38x89mm wood framing, with R.S.I. 3.5 batt installation, vapor barrier and 12mm painted drywall. (See Figure No. 1.)

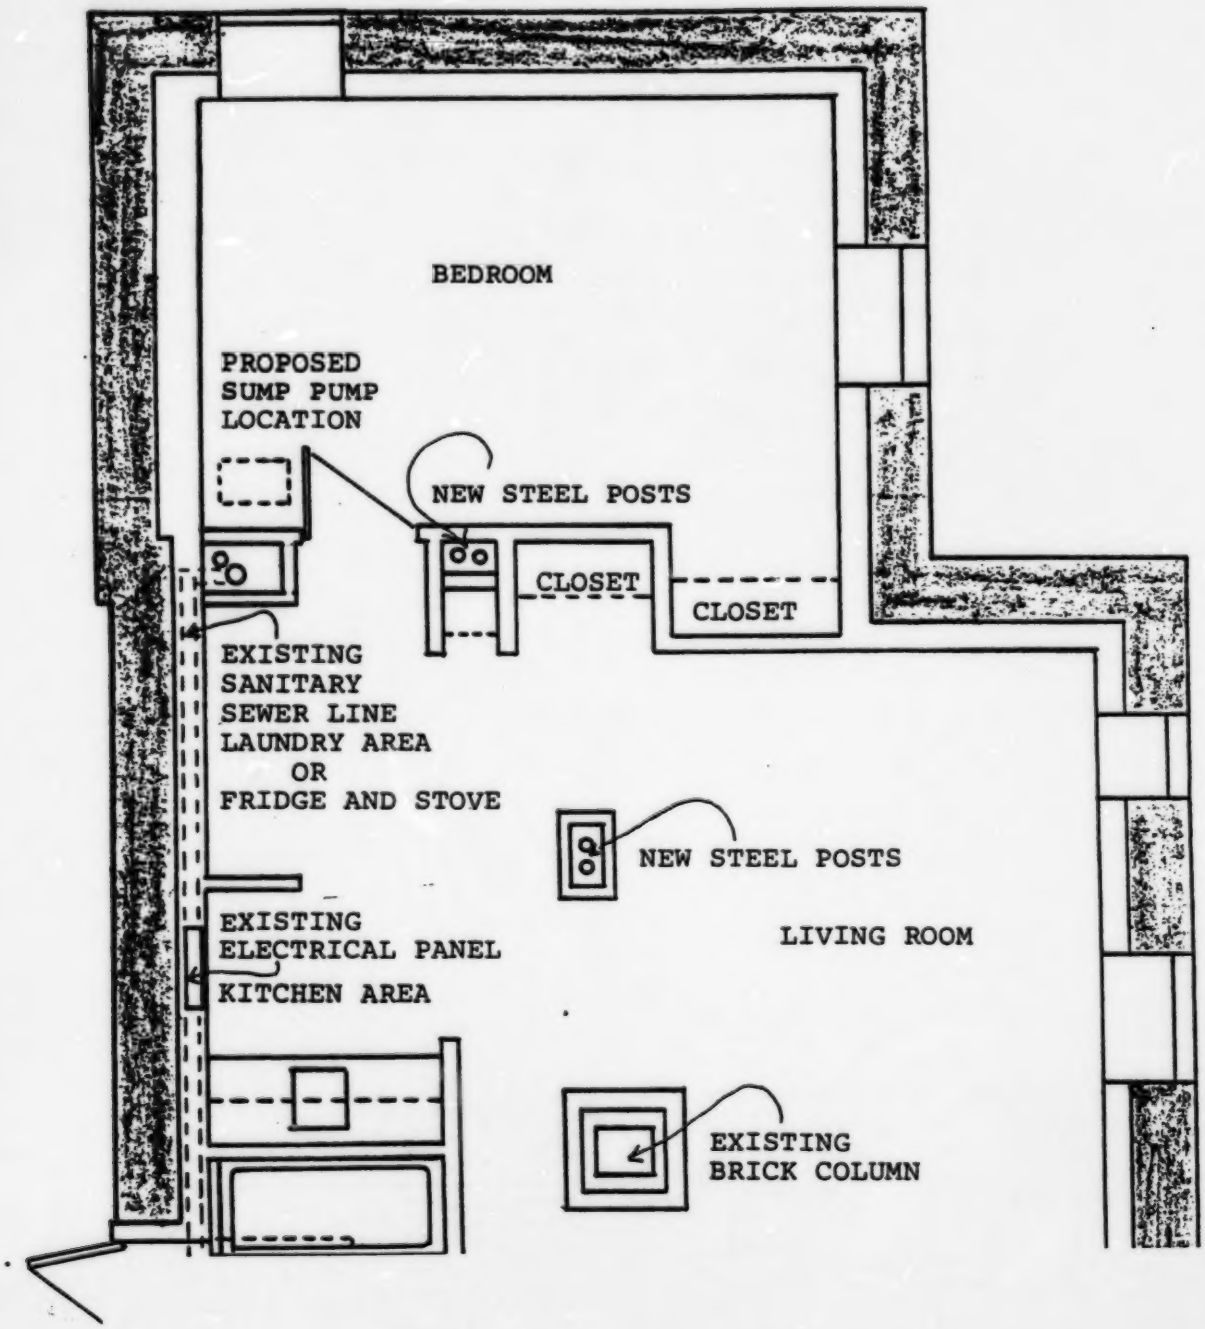
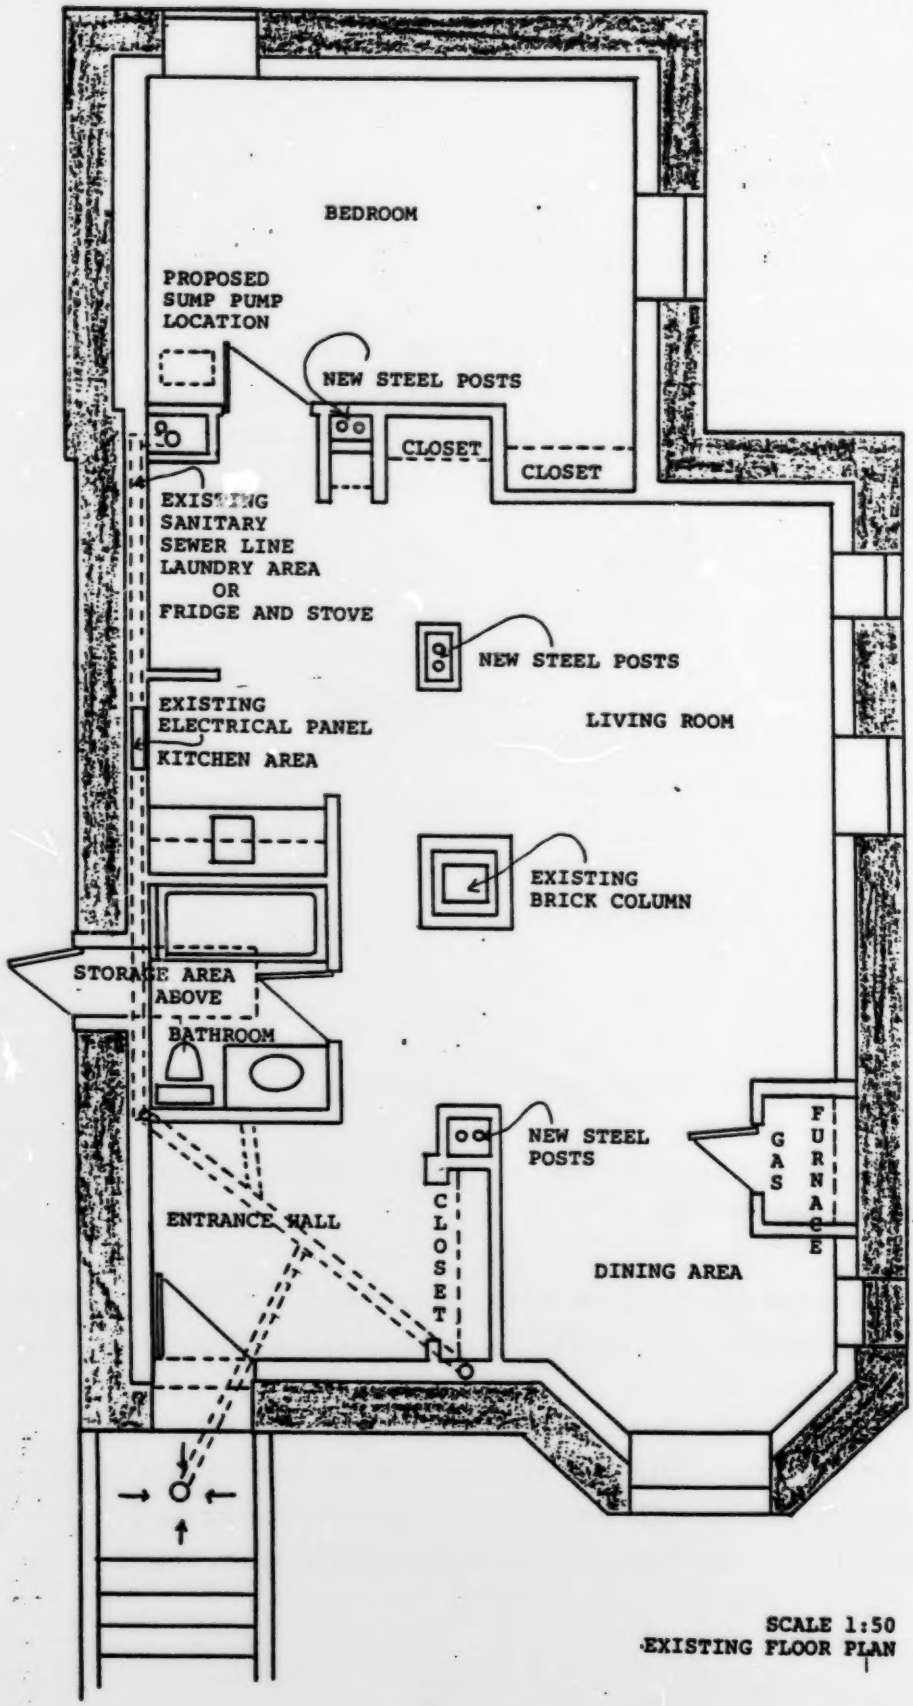
SCALE 1:50
EXISTING FLOOR PLAN

the perimeter, leaving about 100mm to 150mm of soil beyond and below the pier and then a reinforced concrete supporting collar around the supporting soil. Three brick columns were removed because of the obstruction they would have created. These brick columns were replaced with steel jack posts; two posts replaced each brick pier. The one existing brick column which remains, supports the main building support beam at mid span (See Figure No. 2).
